# Home Inspection Report

Prepared for: John Client  
10/01/2019

123 Some Street  
Somewhere, US 12345

Inspected by:  
Will Singer  
Your Company Name Here

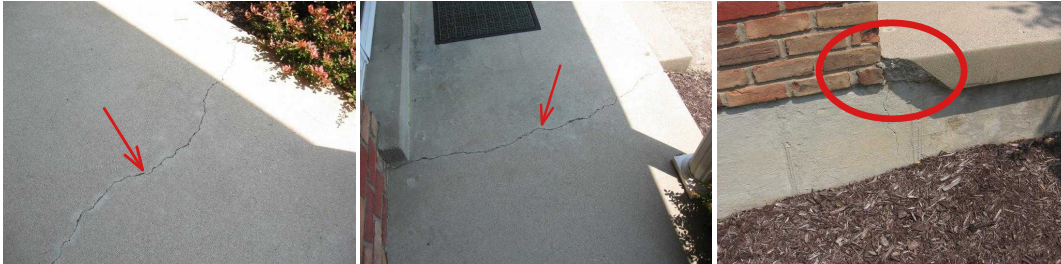
1. ☒ ☐ ☐ ☐ ☐ Driveway: Concrete
2. ☒ ☐ ☐ ☐ ☐ Walks: Concrete
3. ☐ ☐ ☐ ☐ ☒ Porch: Concrete - Settling away from foundation with surface cracks noted

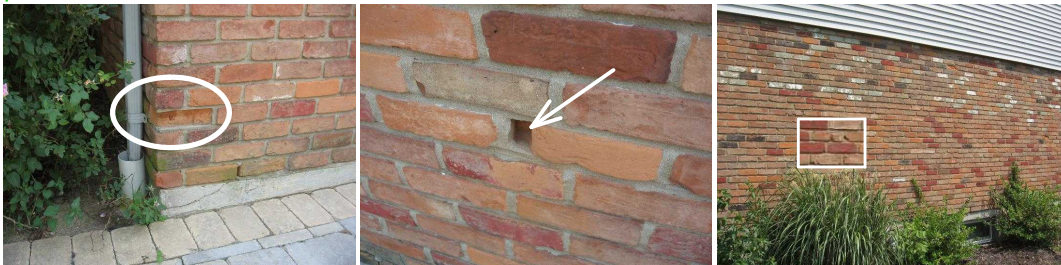
1. ☐ ☐ ☐ ☒ ☐ Type: Brick veneer - Some damaged bricks, Recommend sealing brick with penetration sealer products

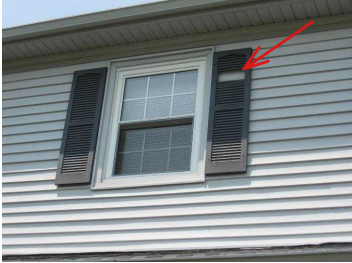
2. ☐☐☐☒☐ Type: Vinyl siding - Damaged front shutter, Chalking noted due to age, One panel needs to be repositioned at rear elevation

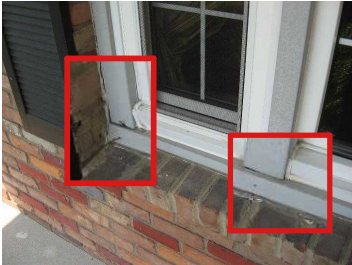
3. ☐☐☐☒☐ Trim: Aluminum - Chalking noted due to age, Loose nails in areas  
4. ☒☐☐☐☐ Fascia: Aluminum  
5. ☐☐☐☒☐ Soffits: Vinyl - Loose/sagging at front porch  
6. ☒☐☐☐☐ Door Bell: Hard wired  
7. ☒☐☐☐☐ Entry Doors: Wood  
8. ☐☐☐☒☐ Patio Door: Vinyl sliding - Resecure loose handle hardware, Screen damage noted  
9. ☐☐☐☒☐ Windows: Vinyl insulated - Reseal caulking at window perimeters at brick window openings

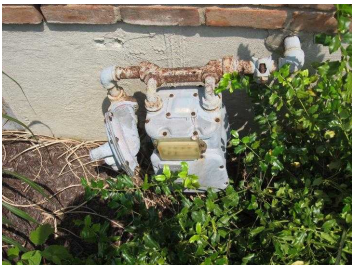
10. ☒☐☐☐☐ Window Screens: Metal  
11. ☒☐☐☐☐ Basement Windows: Vinyl casement  
12. ☒☐☐☐☐ Exterior Lighting: Surface mount  
13. ☒☐☐☐☐ Exterior Electric Outlets: 110 VAC GFCI  
14. ☐☐☐☒☐ Hose Bibs: Gate - Properly secure fixture(s) to exterior wall with fasteners  
15. ☒☐☐☐☐ Gas Meter: Exterior surface mount at side of home - Rust present, Keep bushes and shrubs away from meter

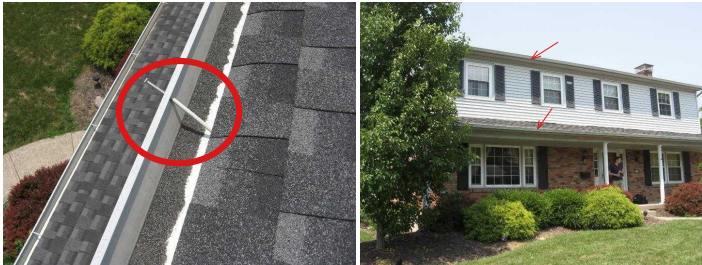
2. ☒ ☐ ☐ ☐ ☐ Unable to Inspect: 0%
3. ☒ ☐ ☐ ☐ ☐ Material: Fiberglass shingle
4. Type: Gable
5. Approximate Age: 5
6. ☒ ☐ ☐ ☐ ☐ Flashing: Metal
7. ☒ ☐ ☐ ☐ ☐ Plumbing Vents: Copper
8. ☒ ☐ ☐ ☐ ☐ Electrical Mast: Underground utilities
9. ☐ ☐ ☐ ☒ ☐ Gutters: Aluminum - Loose nails, Sagging gutters at front and rear

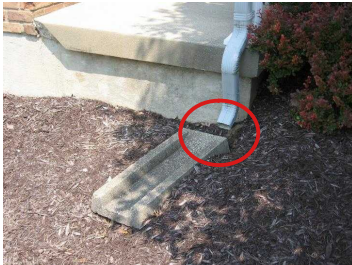
10. ☒ ☐ ☐ ☐ ☐ Downspouts: Aluminum
11. ☐ ☐ ☐ ☒ ☐ Leader/Extension: Splash blocks - Splash block(s) not properly installed

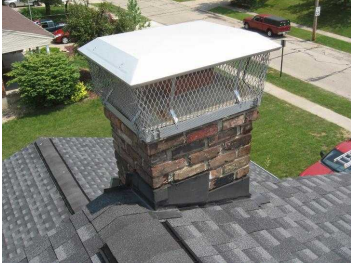
13. ☐☐☒☐☐ Flue/Flue Cap: Clay tile - Weather cap obstructed view of flue

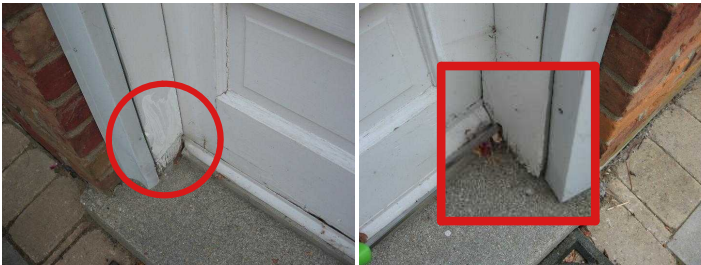
1. Type of Structure: Attached Car Spaces: 2
2. ☒☐☐☐☐ Garage Doors: Insulated aluminum
3. ☒☐☐☐☐ Door Operation: Mechanized
4. ☒☐☐☐☐ Door Opener: Overhead Door
5. ☒☐☐☐☐ Exterior Surface: Brick veneer
6. ☒☐☐☐☐ Roof: Asphalt shingle
7. ☒☐☐☐☐ Roof Structure: 2x6 Rafter
8. ☐☐☐☐☒ Service Doors: Wood - **Wood rot at bottom of door and frame**

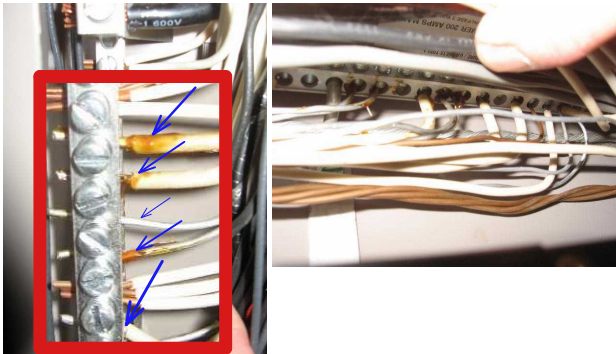
4. ☒ ☐ ☐ ☐ ☐ 240 VAC Branch Circuits: Copper
5. ☐ ☐ ☐ ☒ ☐ Aluminum Wiring: Present at several circuits - Aluminum branch wiring has had a history of problems relating to poor connections due to galvanic corrosion, dissimilar metals, brittle conductors and type of aluminum alloy used during the time period of 1965 through 1972. These problems create unsatisfactory conditions at connections and splice locations and therefore create potential fire hazards. Recommend wiring update for aluminum wiring by a licensed electrician, Circuits are recommended to be upgraded with special compression type connectors at splices and branch circuits to reduce the potential risks of aluminum branch wiring.(Cop-Alum Crimp System)

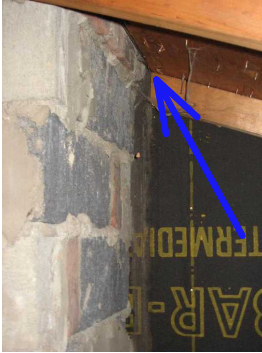
1. Method of Inspection: In the attic
2. ☒ ☐ ☐ ☐ ☐ Unable to Inspect: 15% - Safety and footing
3. ☐ ☐ ☐ ☒ ☐ Roof Framing: 2x3/4 Truss - Wood blocking components missing at chimney perimeter

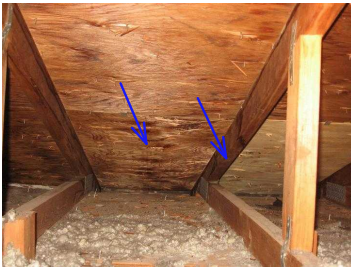
4. ☐ ☐ ☐ ☒ ☐ Sheathing: Plywood - Water stains and slight damage present, Areas of sheathing have been repaired

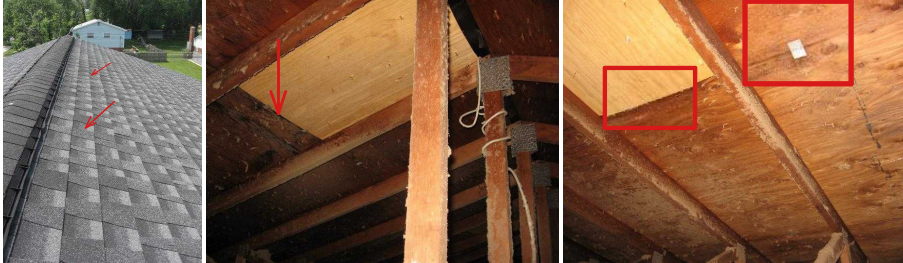
Sheathing: (continued)

9. Method of Inspection: In the attic
10. ☒ ☐ ☐ ☐ ☐ Unable to Inspect: 10% - Safety and footing
11. ☒ ☐ ☐ ☐ ☐ Roof Framing: 2x3/4 Truss
12. ☐ ☐ ☐ ☒ ☐ Sheathing: Plywood - Poor repair at 2 areas near ridge at rear slope - No H clips installed and repair only spanned one truss - Recommend additional support be installed

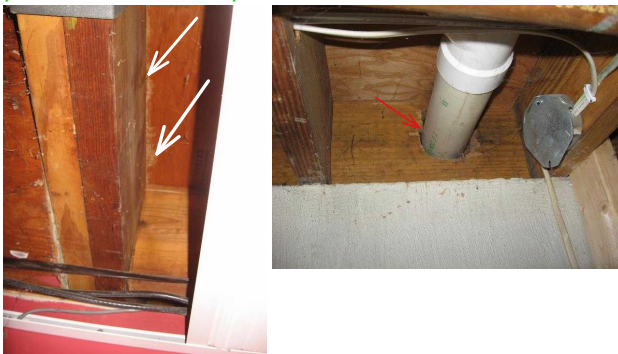
1. ☒ ☐ ☐ ☐ ☐ Structure Type: Wood frame  
2. ☒ ☐ ☐ ☐ ☐ Foundation: Poured concrete  
3. ☒ ☐ ☐ ☐ ☐ Differential Movement: Slight settlement present - Minor settlement at front porch, Cracks will require monitoring  
4. ☒ ☐ ☐ ☐ ☐ Beams: Steel I-Beam  
5. ☒ ☐ ☐ ☐ ☐ Bearing Walls: Wood frame  
6. ☐ ☐ ☐ ☒ ☐ Joists/Trusses: 2x10 - Areas not visible due to ceiling finishes or other obstructions, Framing joist near fireplace chimney shows evidence of previous termite infestation - No repairs required, Seal penetration as required

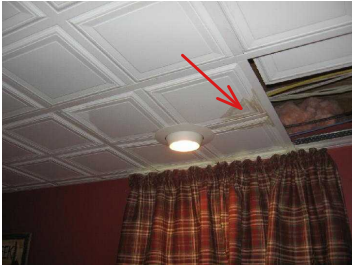
2. ☒ ☐ ☐ ☐ ☐ Ceiling: Suspended Acoustical System - Evidence of past water staining

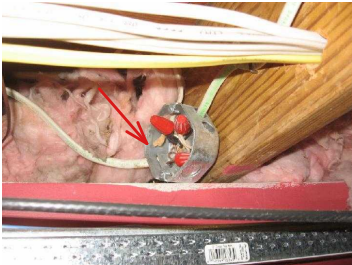
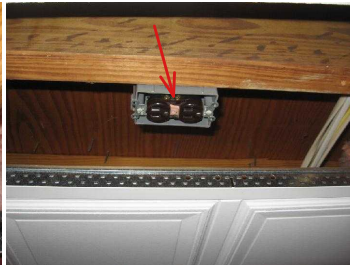
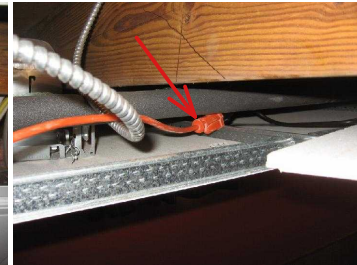
8. ☐ ☐ ☐ ☒ ☐ Electrical: 110 VAC - Loose junction boxes, missing and mis-sized covers, extension cord wiring to projector

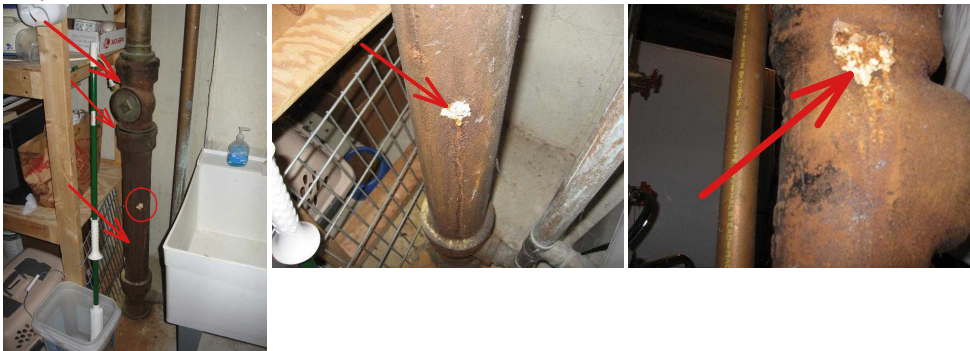
1. ☒ ☐ ☐ ☐ ☐ Service Line: Copper
2. ☒ ☐ ☐ ☐ ☐ Main Water Shutoff: Basement
3. ☒ ☐ ☐ ☐ ☐ Water Lines: Copper
4. ☐ ☐ ☐ ☐ ☒ Drain Pipes: Cast iron, Copper - **Pitting cast iron drain piping stack - replace affected sections where required**

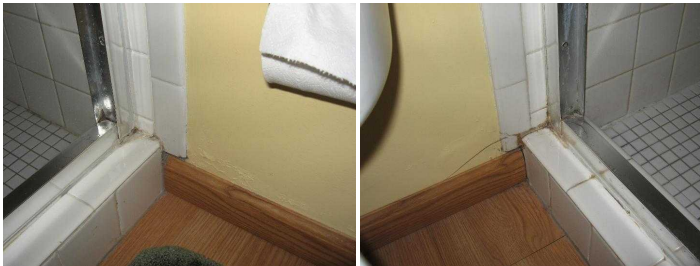
1. ☒ ☐ ☐ ☐ ☐ Ceiling: Drywall
2. ☒ ☐ ☐ ☐ ☐ Walls: Drywall
3. ☐ ☐ ☐ ☒ ☐ Floor: Laminated flooring - Gapping noted in planks
4. ☒ ☐ ☐ ☐ ☐ Doors: Hollow wood
5. ☒ ☐ ☐ ☐ ☐ Windows: Vinyl Insulated
6. ☒ ☐ ☐ ☐ ☐ Electrical: GFCI
7. ☒ ☐ ☐ ☐ ☐ Counter/Cabinet: Wood
8. ☒ ☐ ☐ ☐ ☐ Sink/Basin: One piece sink/counter top
9. ☒ ☐ ☐ ☐ ☐ Faucets/Traps: Delta
10. ☐ ☐ ☐ ☒ ☐ Shower/Surround: Ceramic tile - Leaking at corner of door frame

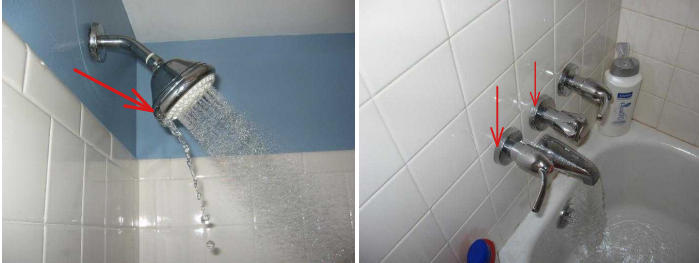
23. ☐☐☐☐☒ Faucets/Traps: Delta fixtures with a metal trap - **Leaking shower head, Loose trim rings**

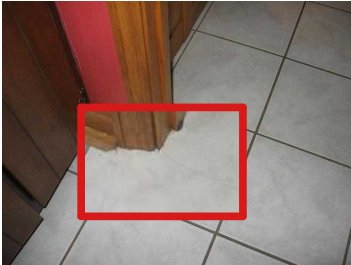
28. ☒☐☐☐☐ Ceiling: Drywall  
29. ☒☐☐☐☐ Walls: Drywall  
30. ☐☐☐☒☐ Floor: Ceramic tile - **Cracked tile noted**

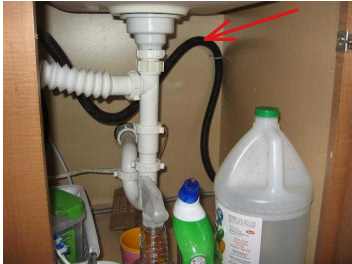
1. ☒ ☐ ☐ ☐ ☐ Cooking Appliances: Frigidaire
2. ☒ ☐ ☐ ☐ ☐ Disposal: General Electric
3. ☐ ☐ ☐ ☒ ☐ Dishwasher: Maytag - Properly secure the dishwasher discharge hose so that it creates a "high loop" above the basin drain to minimize food or water backup under dishwasher

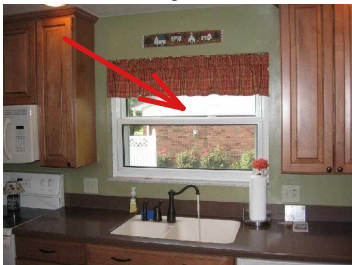
5. ☒ ☐ ☐ ☐ ☐ Refrigerator: Amana
6. ☒ ☐ ☐ ☐ ☐ Microwave: General Electric
7. ☐ ☐ ☐ ☒ ☐ Sink: Stainless Steel - Chipping at drain
8. ☒ ☐ ☐ ☐ ☐ Electrical: 110 VAC GFCI
9. ☒ ☐ ☐ ☐ ☐ Plumbing/Fixtures: Stainless Steel
10. ☒ ☐ ☐ ☐ ☐ Counter Tops: Solid Surface
11. ☒ ☐ ☐ ☐ ☐ Cabinets: Wood - Loose cabinet door hinges
12. ☒ ☐ ☐ ☐ ☐ Pantry: Large
13. ☒ ☐ ☐ ☐ ☐ Ceiling: Drywall
14. ☒ ☐ ☐ ☐ ☐ Walls: Drywall
15. ☒ ☐ ☐ ☐ ☐ Floor: Ceramic tile
16. ☒ ☐ ☐ ☐ ☐ Doors: Hollow wood
17. ☐ ☐ ☐ ☐ ☒ Windows: Vinyl Insulated - Insulated glass unit seal failure

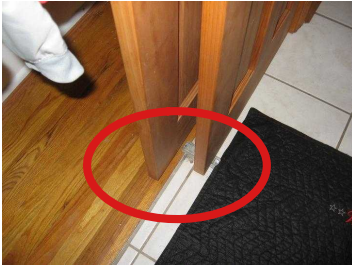
1. ☐ ☐ ☐ ☒ ☐ Closet: Various - Missing door glides at bypass closet door in Foyer

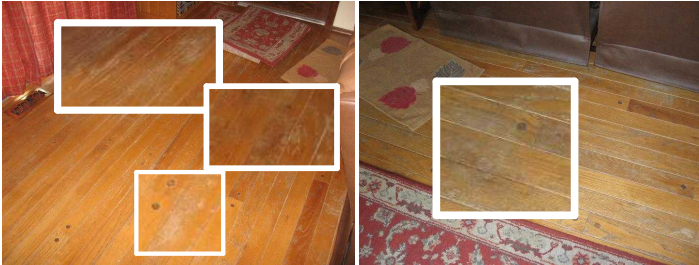
4. ☐ ☐ ☐ ☒ ☐ Floor: Ceramic tile, Carpet, Hardwood - Worn wood finish in Family room

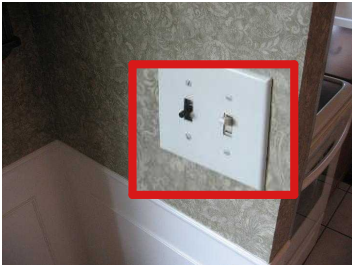
7. ☒ ☐ ☐ ☐ ☐ Electrical: 110 VAC - Replace missing dimmer switch in Dining room

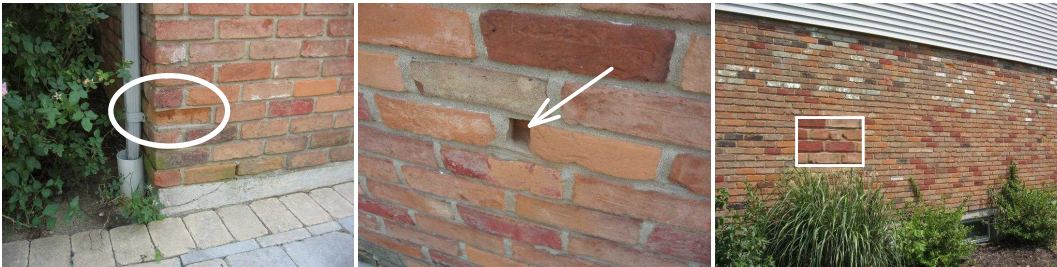
2. 1st Floor Exterior Surface Type: Brick veneer - **Some damaged bricks, Recommend sealing brick with penetration sealer products**

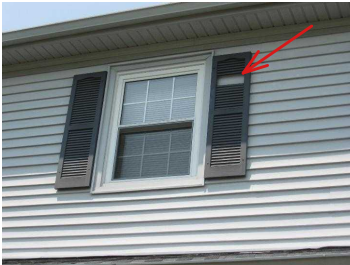
3. 2nd Floor Exterior Surface Type: Vinyl siding - **Damaged front shutter, Chalking noted due to age, One panel needs to be repositioned at rear elevation**

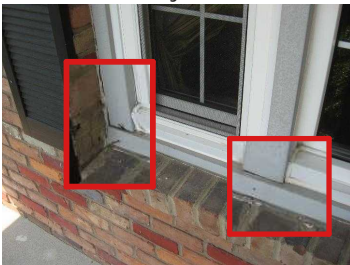
4. Trim: Aluminum - **Chalking noted due to age, Loose nails in areas**
5. Soffits: Vinyl - **Loose/sagging at front porch**
6. Patio Door: Vinyl sliding - **Resecure loose handle hardware, Screen damage noted**
7. Windows: Vinyl insulated - **Reseal caulking at window perimeters at brick window openings**

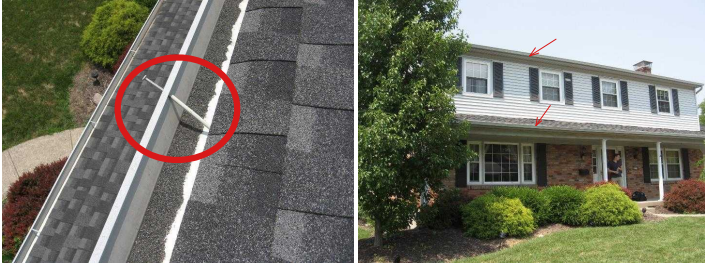
Gutters: (continued)

9. Gutters: Aluminum - **Loose nails, Sagging gutters at front and rear**

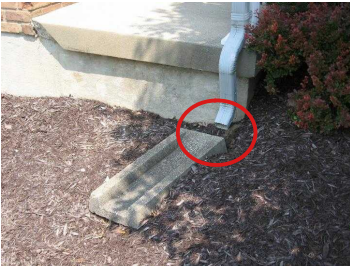
10. Leader/Extension: Splash blocks - **Splash block(s) not properly installed**

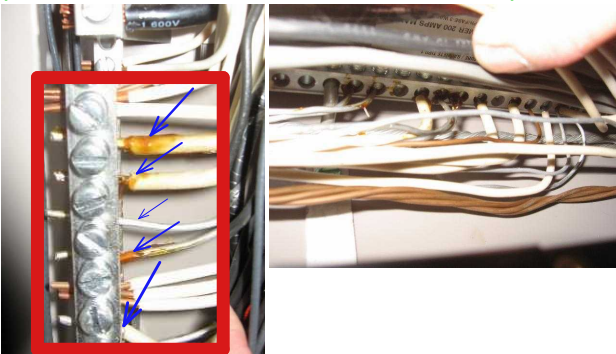
14. 120 VAC Branch Circuits: Copper and aluminum - **Evaluation by a licensed electrician is recommended, See aluminum wiring notes below**  
15. Aluminum Wiring: Present at several circuits - **Aluminum branch wiring has had a history of problems relating to poor connections due to galvanic corrosion, dissimilar metals, brittle conductors and type of aluminum alloy used during the time period of 1965 through 1972. These problems create unsatisfactory conditions at connections and splice locations and therefore create potential fire hazards. Recommend wiring update for aluminum wiring by a licensed electrician, Circuits are recommended to be upgraded with special compression type connectors at splices and branch circuits to reduce the potential risks of aluminum branch wiring.(Cop-Alum Crimp System)**

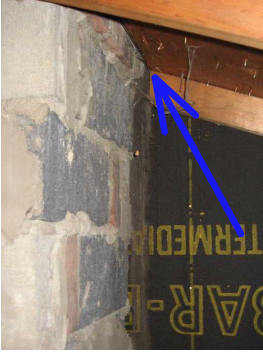
16. Attached Garage Attic Roof Framing: 2x3/4 Truss - Wood blocking components missing at chimney perimeter

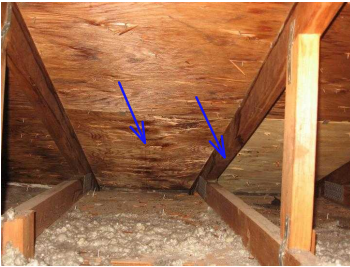
17. Attached Garage Attic Sheathing: Plywood - Water stains and slight damage present, Areas of sheathing have been repaired

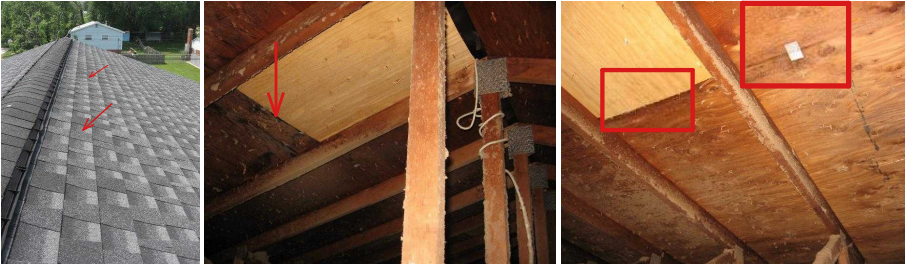
18. Main Attic Sheathing: Plywood - Poor repair at 2 areas near ridge at rear slope - No H clips installed and repair only spanned one truss - Recommend additional support be installed

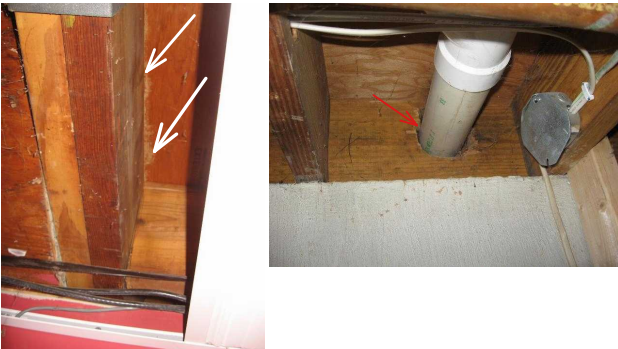
19. Joists/Trusses: 2x10 - Areas not visible due to ceiling finishes or other obstructions, Framing joist near fireplace chimney shows evidence of previous termite infestation - No repairs required, Seal penetration as required

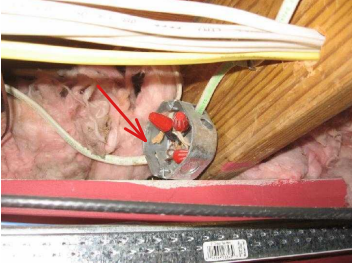
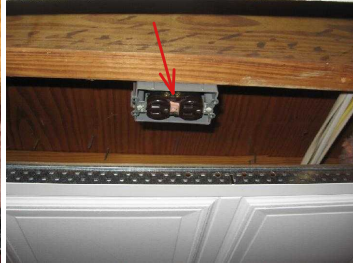
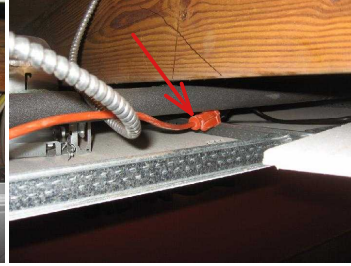
- 20. Main Basement Floor: Carpet - **Carpet stains noted**
- 21. Main Basement Electrical: 110 VAC - **Loose junction boxes, missing and mis-sized covers, extension cord wiring to projector**

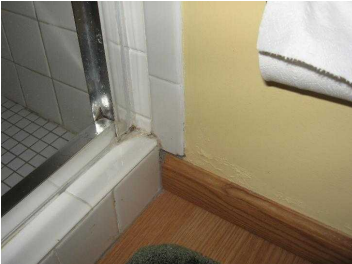
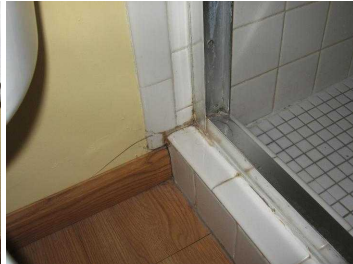
- 22. Master Bathroom Floor: Laminated flooring - **Gapping noted in planks**
- 23. Master Bathroom Shower/Surround: Ceramic tile - **Leaking at corner of door frame**

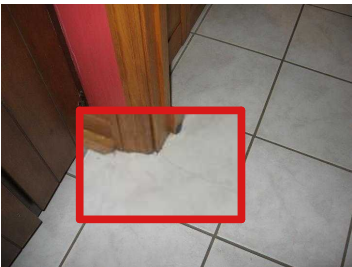
- 24. 2nd Floor Hall Bathroom Closet: Large - **Alignment needed at closet doors**
- 25. 2nd Floor Hall Bathroom Floor: Laminated flooring - **Gapping noted in planks**
- 26. 1st Floor Hall Half Bathroom Floor: Ceramic tile - **Cracked tile noted**

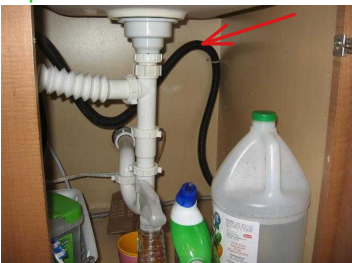
- 27. 1st Floor Kitchen Dishwasher: Maytag - **Properly secure the dishwasher discharge hose so that it creates a "high loop" above the basin drain to minimize food or water backup under dishwasher**

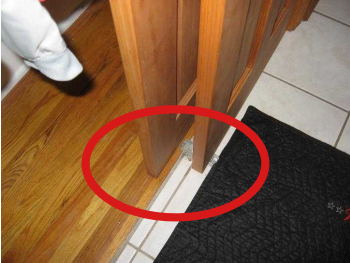
29. 1st Floor Living Space Closet: Various - Missing door glides at bypass closet door in Foyer

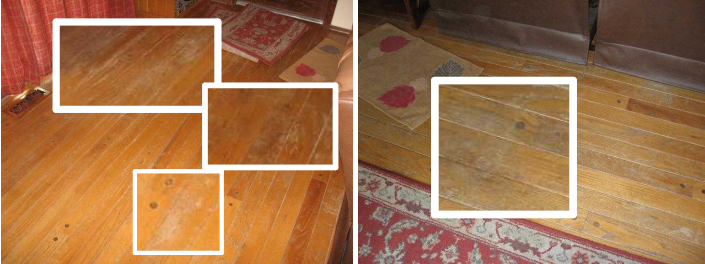
30. 1st Floor Living Space Floor: Ceramic tile, Carpet, Hardwood - Worn wood finish in Family room

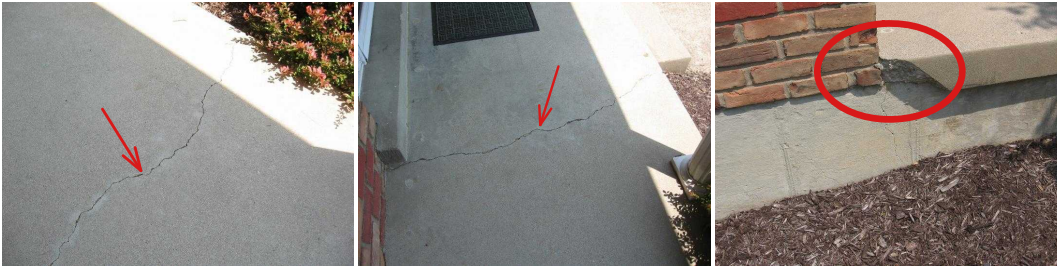
1. Porch: Concrete - **Settling away from foundation with surface cracks noted**

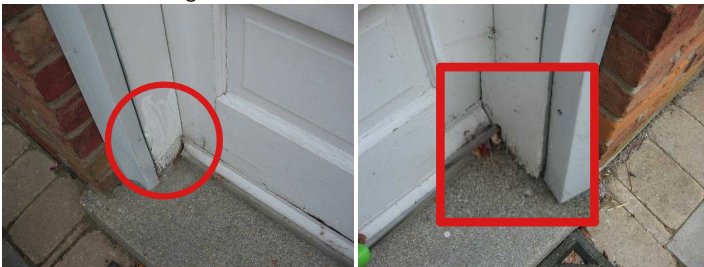
2. Attached Garage Service Doors: Wood - **Wood rot at bottom of door and frame**

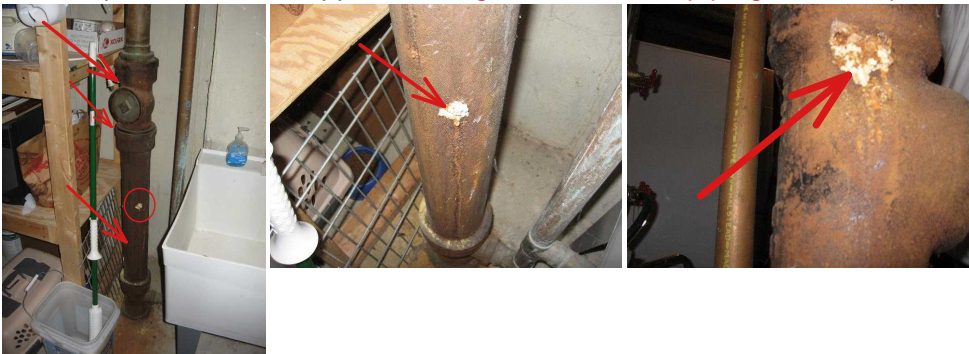
4. Drain Pipes: Cast iron, Copper - **Pitting cast iron drain piping stack - replace affected sections where required**

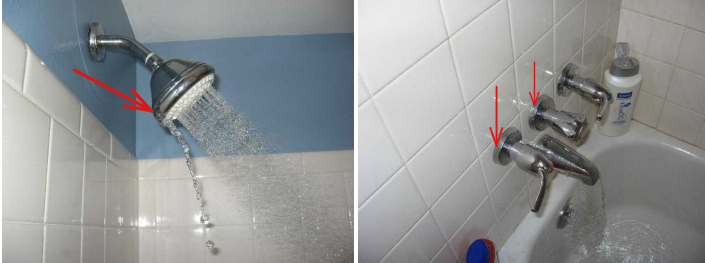
Faucets/Traps: (continued)

5. 2nd Floor Hall Bathroom Faucets/Traps: Delta fixtures with a metal trap - **Leaking shower head, Loose trim rings**

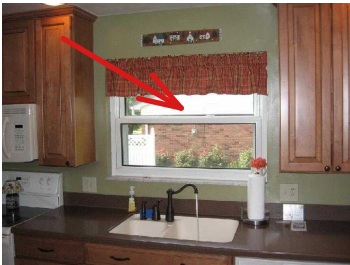
6. 1st Floor Kitchen Windows: Vinyl Insulated - Insulated glass unit seal failure
