# Home Inspection Report

Prepared for: John Client  
10/01/2019

123 Some Street  
Somewhere, US 12345

Inspected by:  
Will Singer  
Your Company Name Here

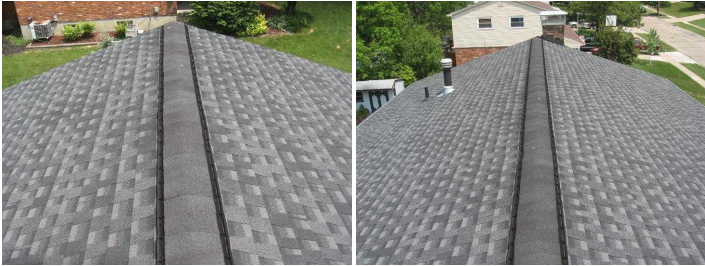
#### 1. Method of Inspection: On roof

2. ☒ ☐ ☐ ☐ ☐ Unable to Inspect: 0%
3. ☒ ☐ ☐ ☐ ☐ Material: Fiberglass shingle
4. Type: Gable
5. Approximate Age: 5
6. ☒ ☐ ☐ ☐ ☐ Flashing: Metal
7. ☒ ☐ ☐ ☐ ☐ Plumbing Vents: Copper
8. ☒ ☐ ☐ ☐ ☐ Electrical Mast: Underground utilities
9. ☐ ☐ ☐ ☒ ☐ Gutters: Aluminum - Loose nails, Sagging gutters at front and rear

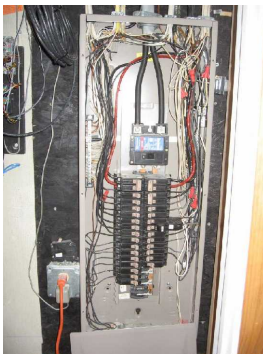
Basement Electric Panel

9. ☒ ☐ ☐ ☐ ☐ Manufacturer: Cutler-Hammer

10. Maximum Capacity: 200 Amps
11. ☒ ☐ ☐ ☐ ☐ Main Breaker Size: 200 Amps
12. ☒ ☐ ☐ ☐ ☐ Breakers: Copper
13. ☒ ☐ ☐ ☐ ☐ AFCI: 110 volt
14. ☒ ☐ ☐ ☐ ☐ GFCI: Present

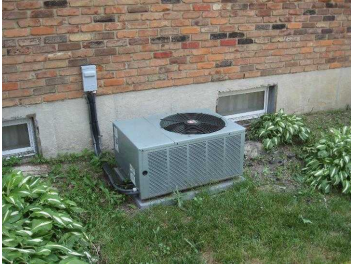
### Main AC System

1. ☒ ☐ ☐ ☐ ☐ A/C System Operation: Appears serviceable
2. ☒ ☐ ☐ ☐ ☐ Condensate Removal: Plastic tubing
3. ☒ ☐ ☐ ☐ ☐ Exterior Unit: Pad mounted

4. Manufacturer: Rheem
5. Area Served: Whole house Approximate Age: 7
6. Fuel Type: 110 VAC Temperature Differential: 16 degrees
7. Type: Central A/C Capacity: 3 Ton
8. ☒ ☐ ☐ ☐ ☐ Visible Coil: Copper core with aluminum fins
9. ☒ ☐ ☐ ☐ ☐ Refrigerant Lines: Serviceable condition
10. ☒ ☐ ☐ ☐ ☐ Electrical Disconnect: Breaker disconnect
11. ☒ ☐ ☐ ☐ ☐ Exposed Ductwork: Metal
12. ☒ ☐ ☐ ☐ ☐ Blower Fan/Filters: Direct drive with electronic filter
13. ☒ ☐ ☐ ☐ ☐ Thermostats: Single Zone

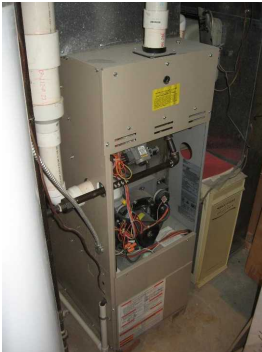
### Basement Heating System

1. ☒ ☐ ☐ ☐ ☐ Heating System Operation: Appears functional

2. Manufacturer: Ducane
3. Type: Forced air Capacity: 100,000 BTUHR
4. Area Served: Whole house Approximate Age: 6
5. Fuel Type: Natural gas
6. ☒ ☐ ☐ ☐ ☐ Heat Exchanger: 5 Burner
